WES KNOWLEDGE CAPTURE

REPORT

WP4 – Supply Chain

OYKNOW-REP-0003

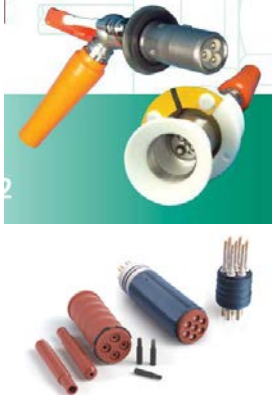
Table 1 – Summary of subsea connectors available

Range of Connector	Rubber-moulded	Metal-shelled	Oil-filled
<u>Image</u>

<u>Suppliers (Location)</u>	MacArtney (Denmark) Seacon (UK) Scorpion Oceanics (UK) (These 3 in fact all supply a range of connectors which are compatible (inter-matable) with Subconn's)	Seacon (UK) Scorpion Oceanics (Souriau) (France, UK distributor) Bowtech (same connectors as Seacon) Gisma (Germany) Teledyne (USA) MacArtney (API connectors range, Denmark)	Expro Group (DigiTron connector, have a UK office) Gisma (Germany) Teledyne (USA) Seacon (UK) Souriau (France, UK distributor)
<u>Price range (order of magnitude per single connector half)</u>	£100	£500	£2000
<u>Notes</u>	This is what Aquamarine Power used originally on Oyster 800. Alternative supplier's products unlikely to perform significantly better.	Positive experience of using this grade of connector has been reported from a tidal energy developer. Aquamarine Power has shown positive experience with this type of connector following testing on Oyster 800. This seems to have resolved the pin corrosion issue. This grade of connector tends to come tested to a number of wet-mate cycles (typically 200-500).	Oil bath allows pressure balance, washes the pins as they are assembled, and protects the sliding contact surfaces. This would probably give the best chance of resolving the pin corrosion issues. These connectors tend to be very large for a given number and size of pin. In addition they have large mating forces (circa 500N). These connectors tend to come with a 25-year design life, and tested to a number of mate-de-mate cycles (typically 500)

Aquamarine Power have identified three different types of subsea connectors available on the market. These are summarised in Table 1.

Oil-filled connectors offer the best solution technically, however, their high cost make them unfeasible for projects involving a large amount of instruments. A compromise solution are the metal shelled connectors which offer a half-way house between the two other designs.

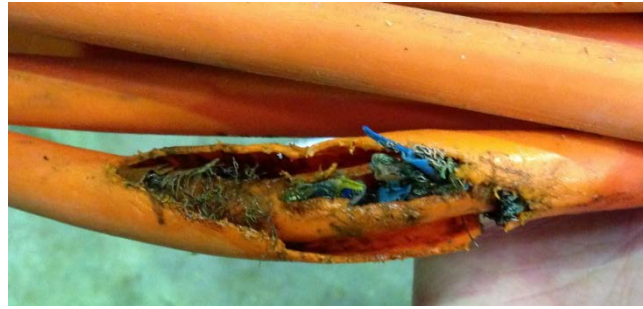
Figure 4 – Example of failed cable

Loss of data due to cables abrading, severing, straining and/or crushed.

1. Poor selection of materials provided as subsea cables;
2. Inadequate construction;
3. Inadequate design;
4. Inadequate protection.

APL have worked closely with certain cable manufactures to come up with a suitable design for subsea cables. Different environments require different requirements and hence a standard cable for subsea applications is not available off the shelf, there are various types of cables that may be suitable for certain applications. The following characteristics have been outlined to be considered when selecting or designing cables:

- Polyurethane outer jackets were successful;
- Cables which are to be pulled in should contain an adequate strength member such as Vectran or Kevlar;
- Cables which are expected to see significant impact loads should not be exposed, however exposed sections should incorporate protection within the design. A double jacket with steel wire armour was found to be an adequate way of achieving this;
