WES KNOWLEDGE CAPTURE

REPORT

WP6 – Maintainability Improvements

OYKNOW-REP-0005

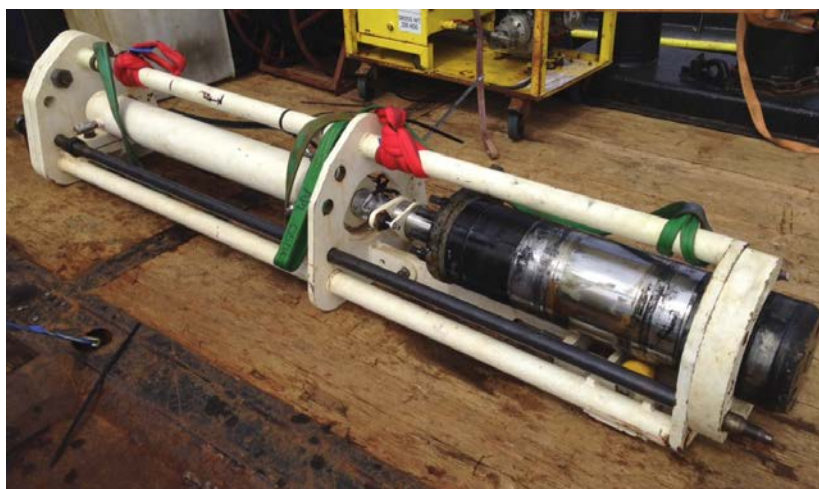
Figure 5 - Bondura Bolt, secured within the bespoke Bondura Bolt removal tool

Each Bondura Bolt pins weighs in the region of 350kg. A bespoke tool was developed to pull and push the pins in and out of position. This tool itself weighed in excess of 1te, and required additional temporary support beams to be installed for support. The installation of the support beams and the tool comprised one of the most time consuming parts of the cylinder exchange activity. Pulling and pushing of the pins themselves was very quick and successful.

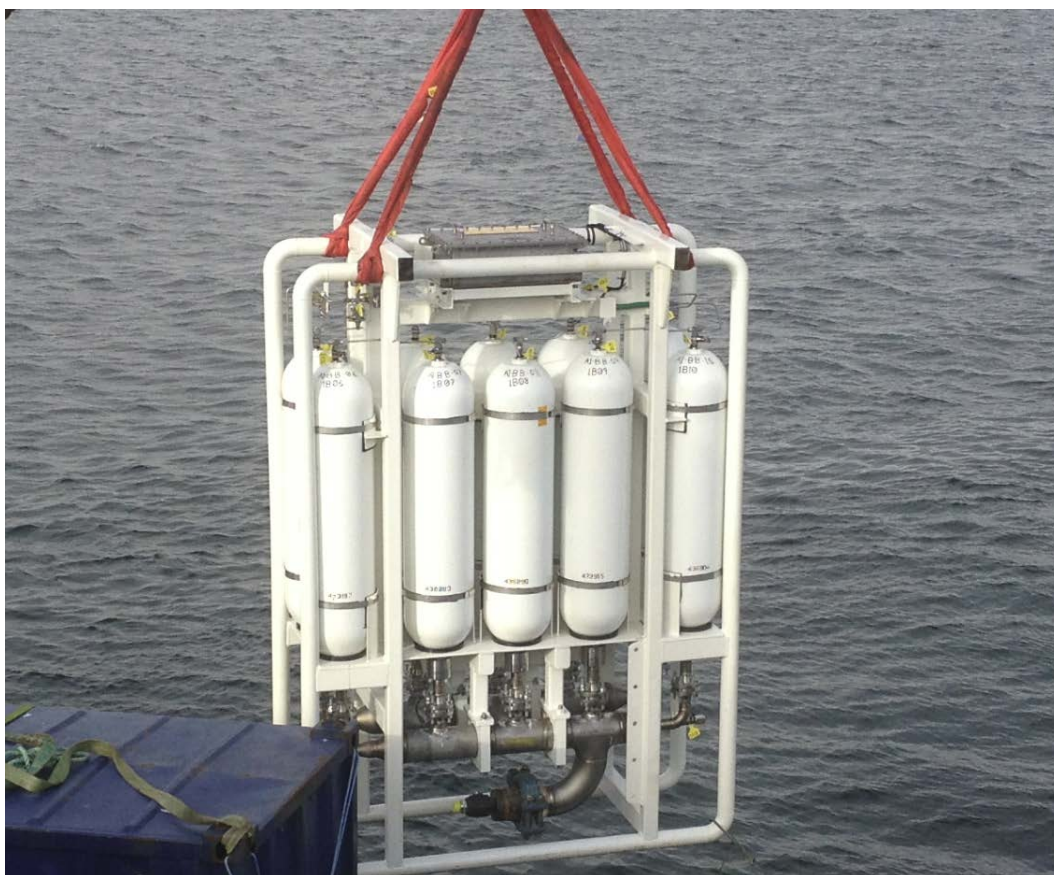
Figure 6 - Oyster 800 accumulator module

By comparison with the Oyster 800 cylinder modules, the accumulator modules were relatively compact. The module weighed in at 4.5te, and initially contained Low Pressure (LP) and High Pressure (HP) accumulators. It was well within the crane capacity, and could be guided into place by the diver using a tag line. Simple guidance features and fendering protected components and assisted positioning of the module. Installation and removal was quick and relatively straightforward- it could be expected to take no more than half a day to complete the entire operation. Installation of the module could be completed in 30 minutes. The rest of the time would be spent on installation of the flexihose and flange tightening, an operation that proved time consuming.

The module had a minimal number of interfaces. Flexible hoses were again used, with flange connections to the HP and LP fixed pipework and Techlok hub type flanges to connect to the module. The hoses were installed and connected vertically at the flange connection. Hose positioning was readily achieved by connecting a pulling line, passed through the bolt holes on the mating flange, to a lift bag.

Four mechanical fixings were used on each corner to secure the module in position. Vibrations from the baseframe and the module caused these fixings to regularly come loose. Bolted connections are a complex issue on Wave Energy Convertors. Aquamarine Power has spent a lot of time during its PIP+ programme in 2014 developing a robust bolting methodology which gave greater confidence in the integrity of the bolted connection solutions and which will address issues such as this.

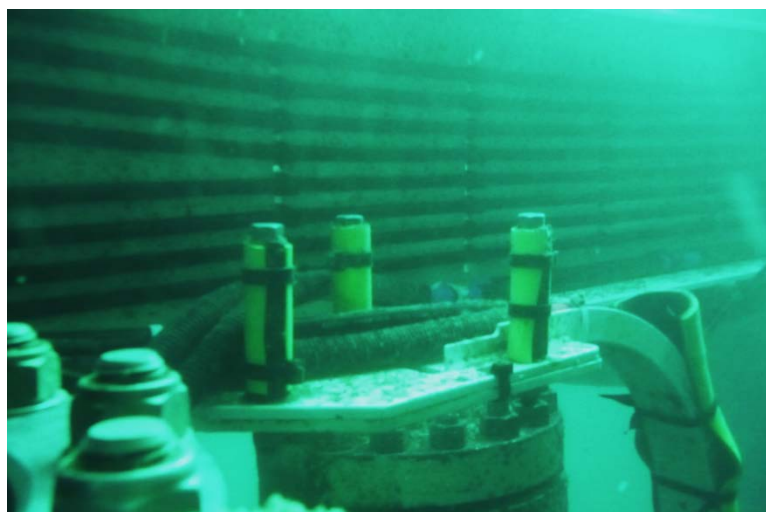
Figure 8 - Cables and hydraulic hoses on robust, open and accessible cable trays

Experience on Oyster 800 has been that robust, open and accessible cable trays proved the most practicable solution for achieving a compromise between survivability and maintenance. Cables could be neatly laid out rather than bundled, ensuring that a single cable can be quickly replaced without needing to release others. C&I improvements are explored in more detail in Section 3.2 of OYKNOW-REP-0003.
